# Simultaneous monitoring of a collapsing landslide with video cameras

K. Fujisawa and J. Ohara

Public Works Research Institute, Japan

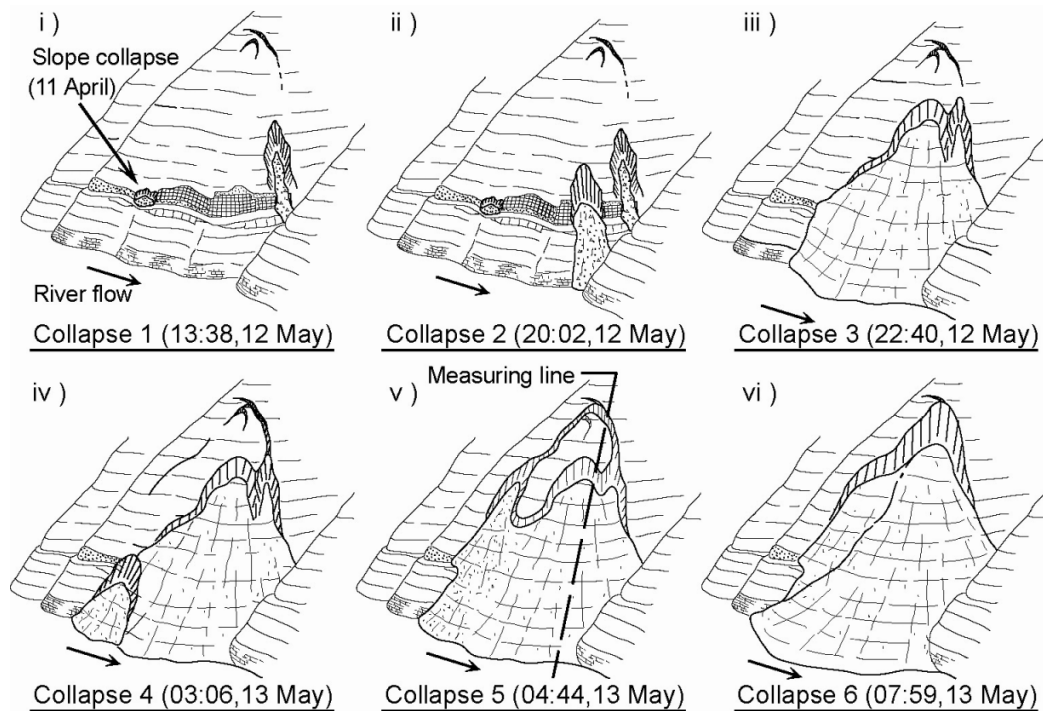
**Fig. 2.** History of collapses.

The analysis of images before and after the landslide showed that the slope collapse involved debris in excess of 1000 m<sup>3</sup>, and that six separate landslide events occurred. Figure 2 shows sketches of each landslide event, numbered 1 through 6. Based on analysis of the images, the sequence of events leading to the landslide is thought to be as follows:

1. Slope collapse is confirmed on the slope next to the road on the mountain on 11 April. A major crack is identified at the top of the slope on 21 April. A slope collapse of approx. 2000 m<sup>3</sup> (Fig. 2i) occurs near the downstream extension of the crack at 13:38 on 12 May.

2. Several minor falling rock events occur in the region of Collapse 1 followed by a further slope collapse on 11 April. A second slope collapse of around 1000 m<sup>3</sup> (Fig. 2ii) occurs at 20:02 on 12 May a short distance upstream of Collapse 1.

3. A steady succession of falling rock and slope collapse events begins at 22:23 on 12 May, in the vicinity of Collapses 1 and 2, leading to a major slope collapse of approximately 10 000 m<sup>3</sup> at 22:40 (Fig. 2iii).

4. After a brief hiatus following Collapse 3, the next major slope collapse (Fig. 2iv, estimated at 1000 m<sup>3</sup>) occurs at 03:06 on 13 May near the foot of the slope on the upstream side. Due to the camera angle and poor visibility at night, the images provide only limited detail, although evidence of localized tree shaking suggests that the crack at the head of the landslide was beginning to extend upstream of the slope.

5. A further slope collapse (Fig. 2v, 1000 m<sup>3</sup>) occurs at 04:44 on 13 May on the slope further up the slope from Collapse 4.
6. Falling rock and slope collapse events begin at approximately 07:40 on 13 May on the middle and lower part of the slope and become more frequent, culminating in a major slope collapse (Fig. 2vi, 40 000 m<sup>3</sup>) at 07:59. This is followed by more falling rocks and minor collapses, but without any further significant topographical

Thus, the sequence of events leading up to the landslide began with collapses at the periphery of the landslide area (from the head to the sides and toe), where the effect of stress caused by movement is most apparent, followed by an increasing incidence of falling rocks and minor collapses in the area.

Judging from the analysis of the landslide images of Collapses 1 and 2 (Fig. 2), the first collapses that were the precursors of the landslide occurred mainly at the top of the grating crib works on the mountain side of the road, and the collapse phenomenon just before the sliding of Collapse 6 also occurred mainly at the top of the grating crib works. Thus, it

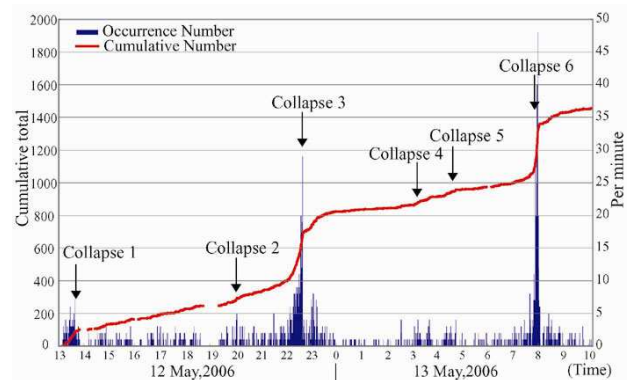
**Fig. 3.** Other events – falling rocks, slope collapses and fallen trees.

Figure 3 shows the count of falling rock events, slope collapses and fallen trees. Prior to the six major collapses, the frequency of these events steadily increased. The rate of increase was particularly pronounced prior to the two largest collapses (numbers 3 and 6).

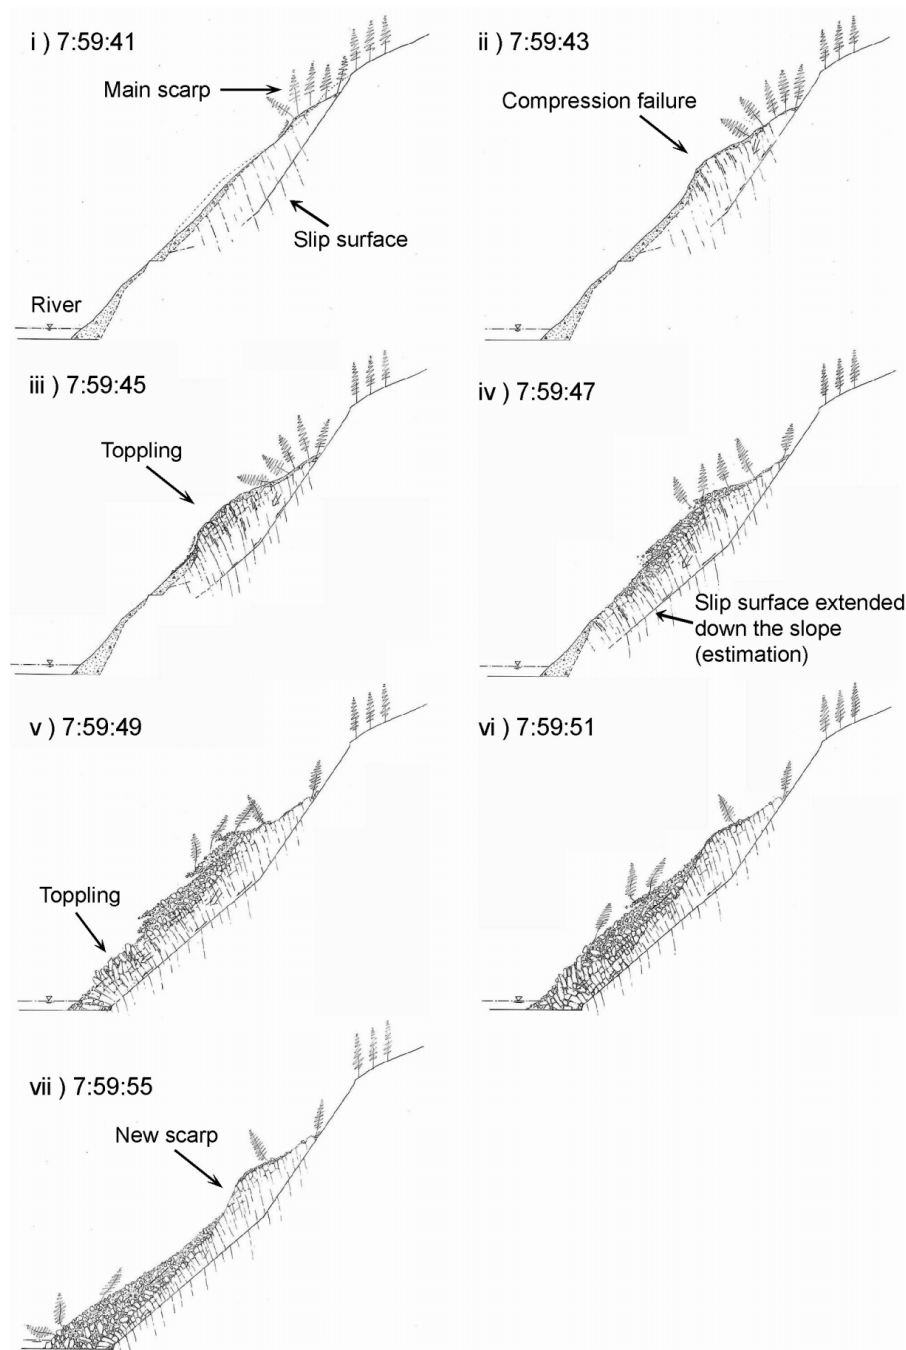
**Fig. 4.** History of collapses during sliding of Collapse 6 (occurring at 7:59 a.m. on 13 May).

Figure 4 shows the results of sketches made for about 20 s during the movement of Collapse 6 shown in Fig. 2 (occurring at 7:59 a.m. on 13 May), the largest slide that occurred while the landslide moved.

As shown in Fig. 4, the section diagrams were estimated based on several images taken from some different angles representing the 20 s from 07:59:35 to 07:59:55 on 13 May. These section diagrams were prepared along the measuring line shown in Fig. 2v. These were used to study the state of change of the moving soil mass accompanying the movement of the landslide.

The results showed that cracks formed in the landslide body located below the main scarp at the time of Collapse 5, and the collapse expanded from that location. When the landslide started to move, many collapses began to occur along the edges of the landslide (head – side/toe) (Fig. 4i). The movement of the landslide is thus assumed to be accompanied by a toppling movement (Fig. 4ii–iii). Afterwards, the head to the middle of the landslide body was crushed, resulting in the formation of debris deposit. (Fig. 4iv) As this debris deposit covered the entire lower part of the slope, the toppling was confirmed at the toe of the landslide (Fig. 4v–vi). It is presumed that the toppling occurred at the toe of the

landslide because the stress produced by the movement of the landslide reached the lower part of the slope. The landslide body remained near the top of the slope; however, because the collapse flowed downward with the toppling, a new scarp was formed near the center of the slope (Fig. 4vii).

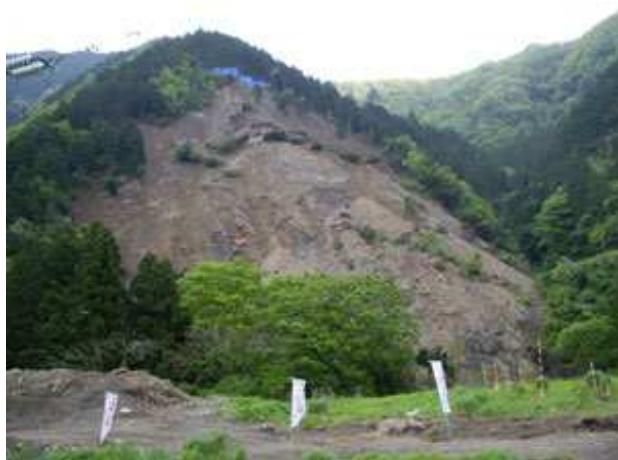
approximately 150 m in width by 135 m in height, with a volume of approximately 250 000 m<sup>3</sup> (Fig. 5).

**Fig. 5.** General view of the landslide site (14 May 2006).

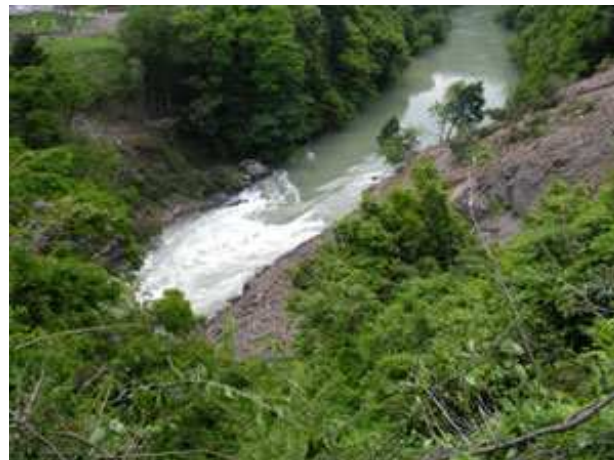
Image analysis, together with field measurements using a ground-based laser scanner after the collapse, indicated that the landslide produced a total of 50 000 m<sup>3</sup> of debris. It flowed into the river during the landslide. As Fig. 6 shows, this blocked some two-thirds of the width of the river, and also caused damage to several local roads, but most of the landslide body remained on the affected slope.

**Fig. 6.** Debris deposits in the river course (14 May 2006).
